SAFETY ALERT / Incident Report

Incident	Fire at an AD/Biogas Plant	Date of Incident	September 2016
Risk Engineer:	Alan Fitzpatrick BSc (Hons) CEng CEnv FBES	Risk Contact	07525-225100 alan.fitzpatrick@cna-hardy.com

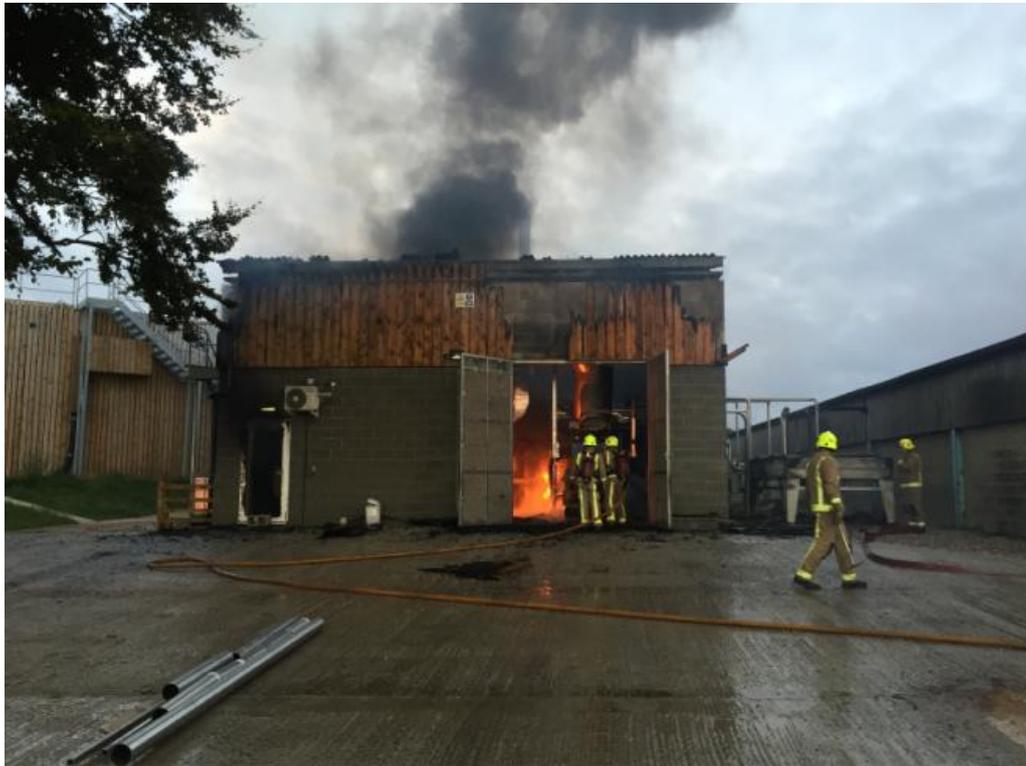
The carbon filter was left open to the atmosphere during maintenance. Site CCTV footage shows this filter expelling dust/debris before igniting/flaming and a major fire subsequently spreading to the building structure. This building's frame was clad in part with timber batons for environmental/ decorative reasons.

The engine and switch rooms of the biogas plant suffered major damage and the plant was unable to operate further after the incident.

4. All fire detection needs to be linked to the operational SCADA systems, to ensure plant operators are alerted. On detection of fire the site plant should enter into a safe mode.

5. The use of combustible construction and insulation materials in biogas plants must be eliminated where possible or reviewed to ensure that the plant has the ability to withstand a fire until the fire brigade arrives with sufficient time to contain the fire spread.
